## Reach 15 Photos

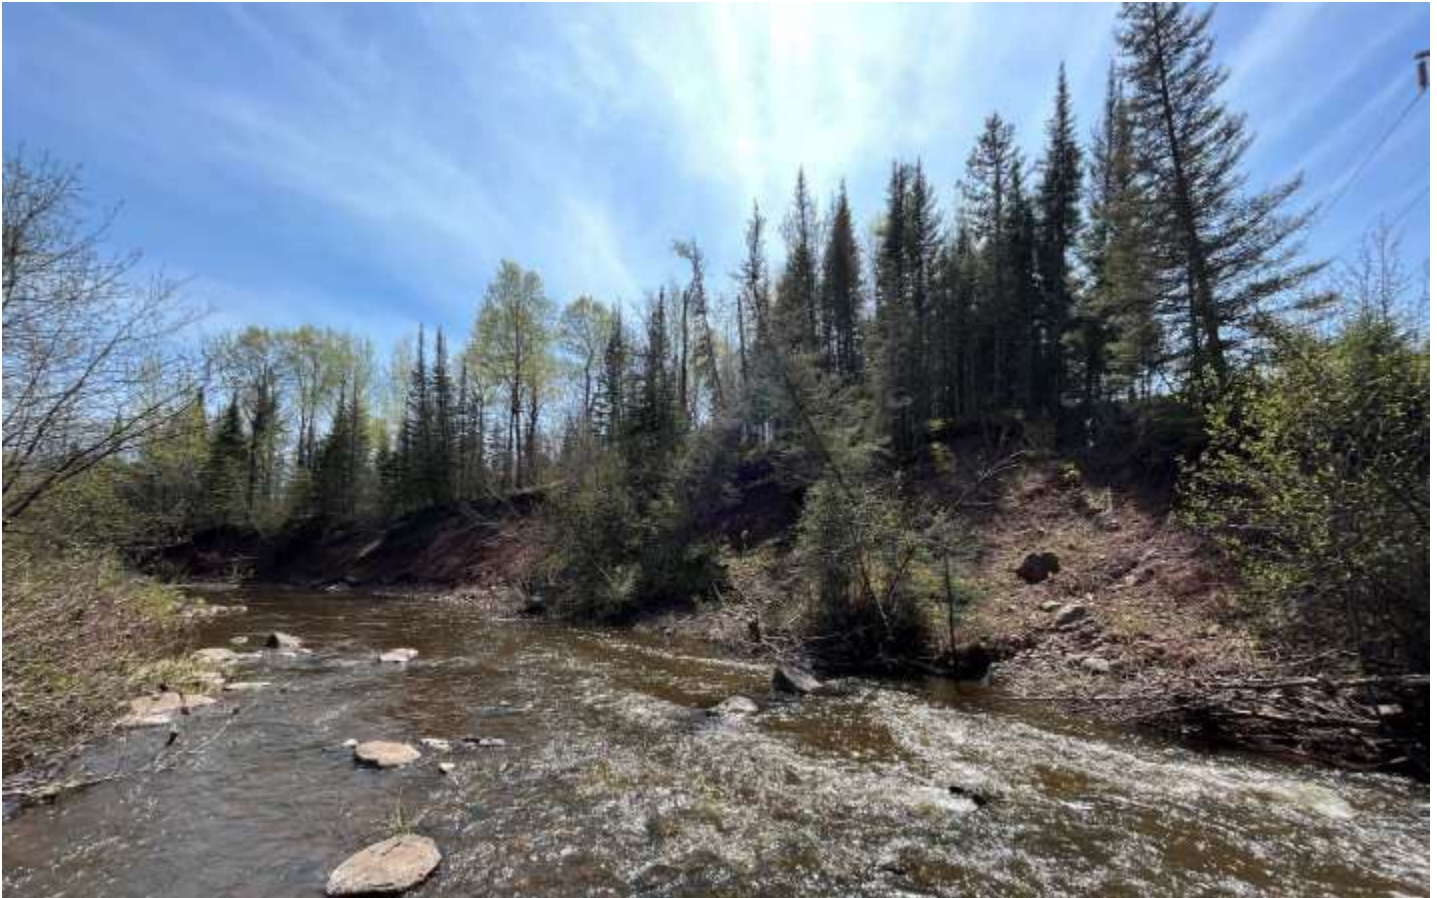
Large-scale streambank erosion. This bank will continue to collapse because the balsam fir on the slope have died due to Spruce Bud Worm. All the trees on the bank will be lost in two years. These dead trees will erode and deposit in the river channel taking hundreds of tons of clay with them. This clay will impact downstream habitats and affect the TMDL.

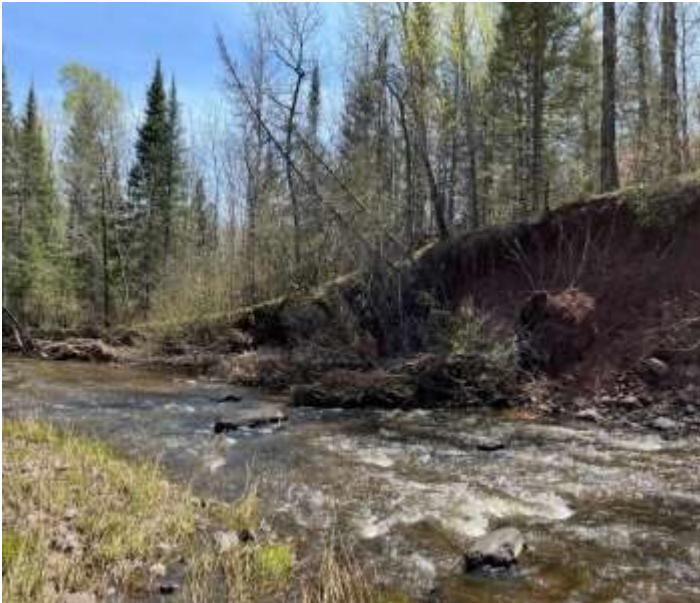
Another collapsing bank. Balsam Fir on the slope are also infected with Spruce Bud Worm. This bank will most likely be a total loss within the next two years. As these eroded trees move downstream during the next flood event, they will deposit on downstream bends and cause a new eroding streambanks and the process will start all over again

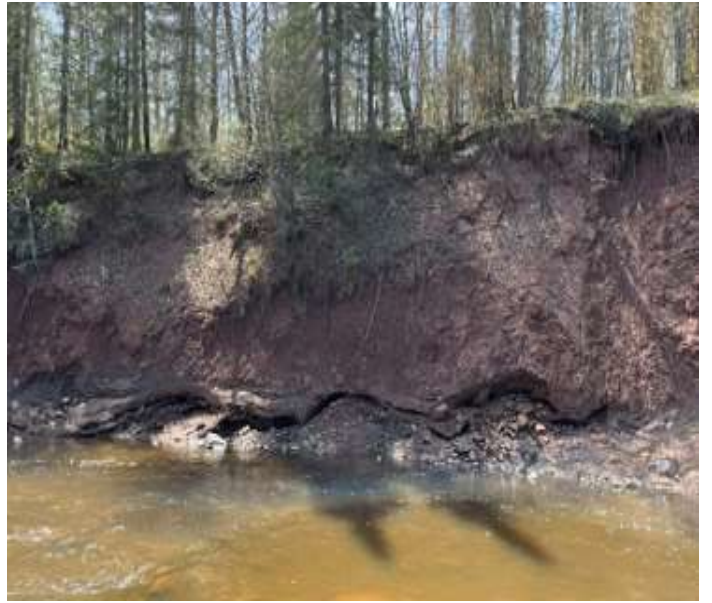
Floodwaters have undercut this stream bank. The granular material at the base of the bank eroded leaving it unstable. This bank will shear and slump during the next large storm and deposit hundreds of tons clay into the channel. This slump will also discharge trees into the channel causing future downstream impacts.

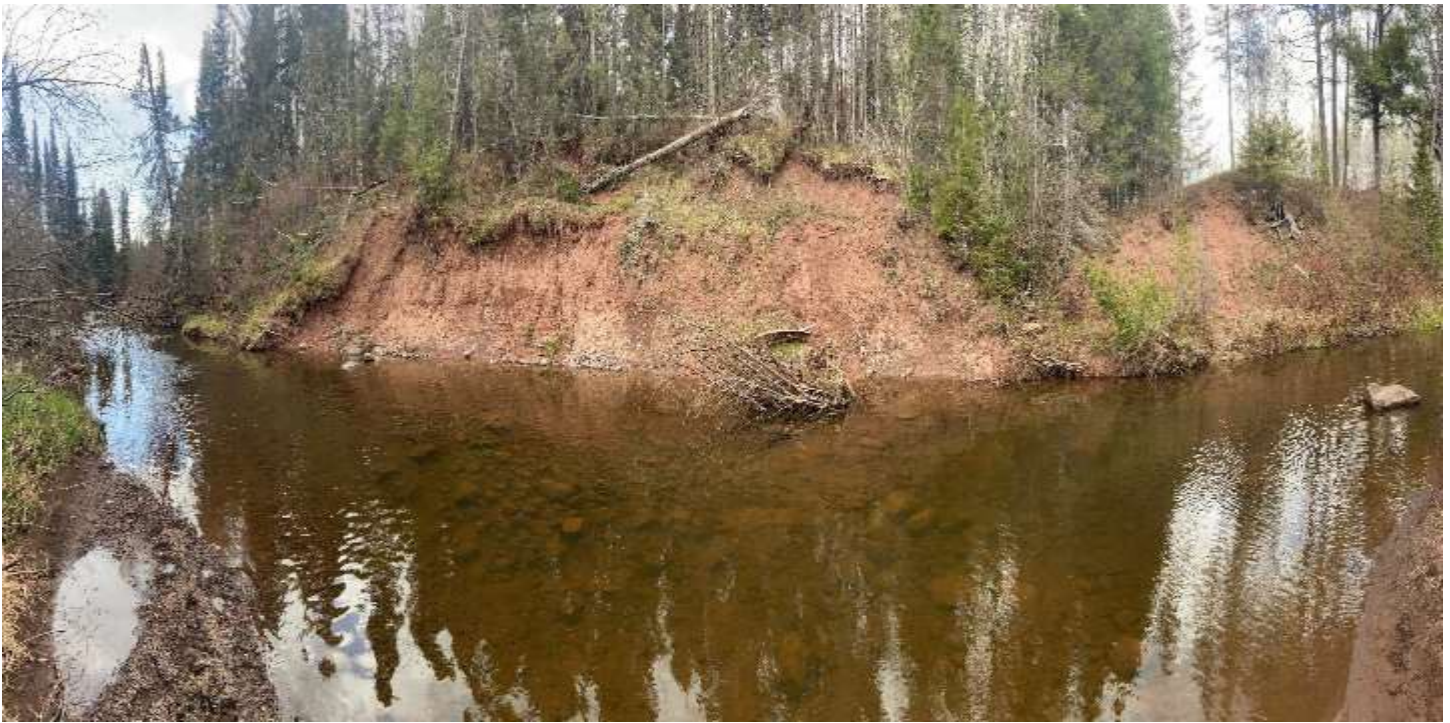
Panaramic photo of a large eroding stream bend. This erosion has displaced healthy trees, which are being deposited into the river. This bank is several hundred feet long and is a major source of the turbidity TMDL exceedance.

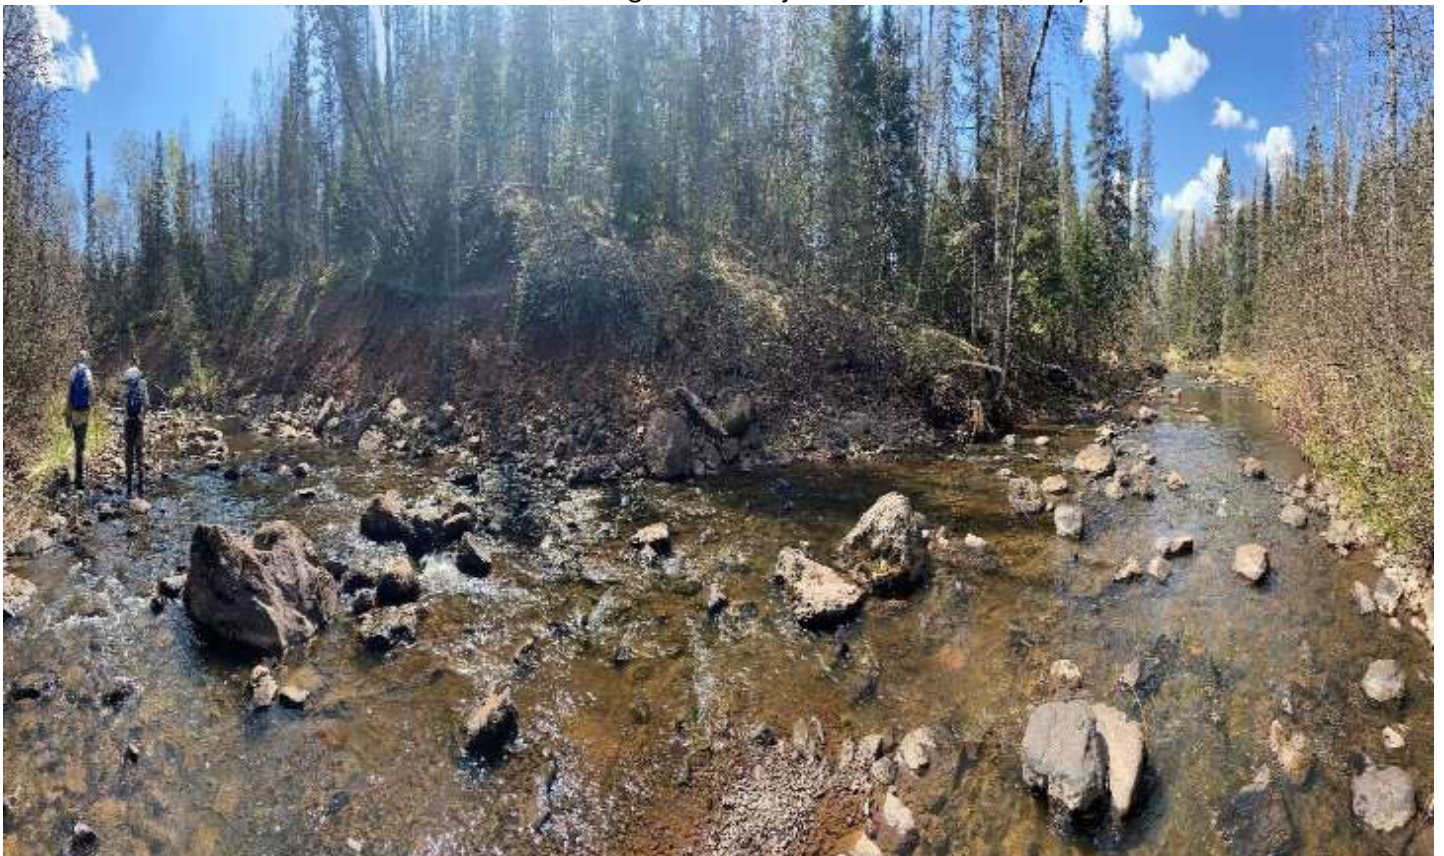
Another panaramic photo of a large eroding stream bend. This bank is different because the soil type is a mixture of clay, cobbles and boulders. Much of the cobbles and boulders in this stream channel, originated from this eroded bank. This deposited rubble filled the channel and now is altering the streamflow. At flood stages this altered flow appears to deflect the stream current to the west, causing erosion on the opposite side of the river. This photo was taken at the end of the erosion, the full extent of the erosion is upstream several hundred feet around the corner of the bend.
