# Knife River Assessment Fall 2015

J15Y133600

Prepared for  
Environmental Troubleshooters

March 11, 2016

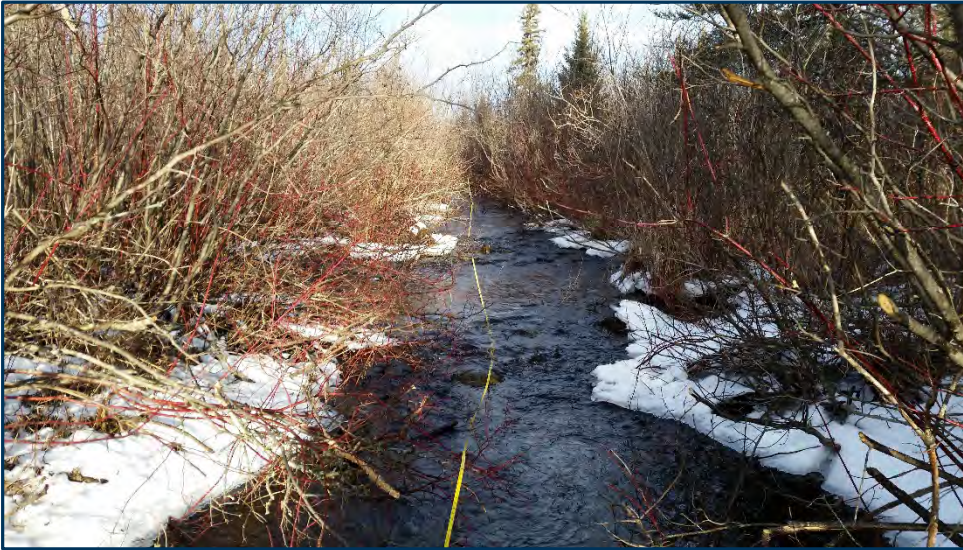
Figure 3-1 Example of stream characteristics along Reach 1

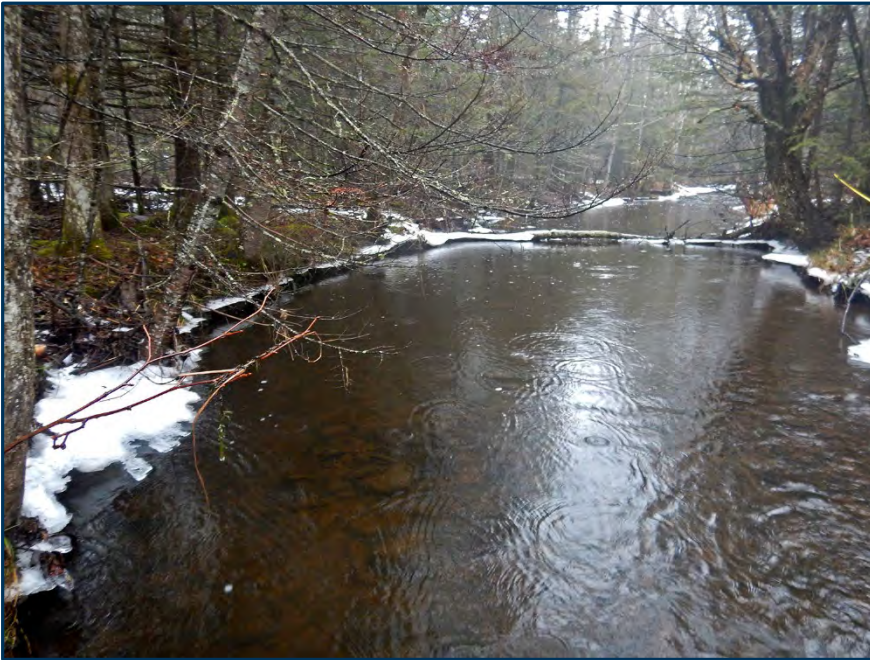
Figure 3-2 Example of stream characteristics along Reach 2

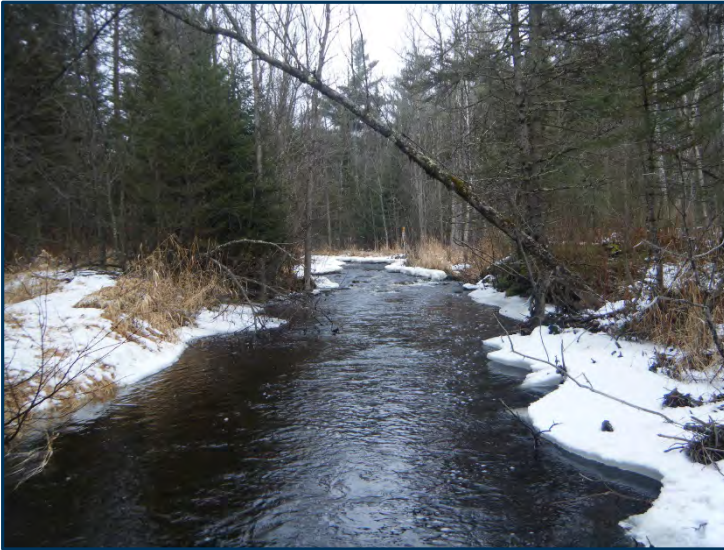
Figure 3-3 Example of stream characteristics along Reach 3

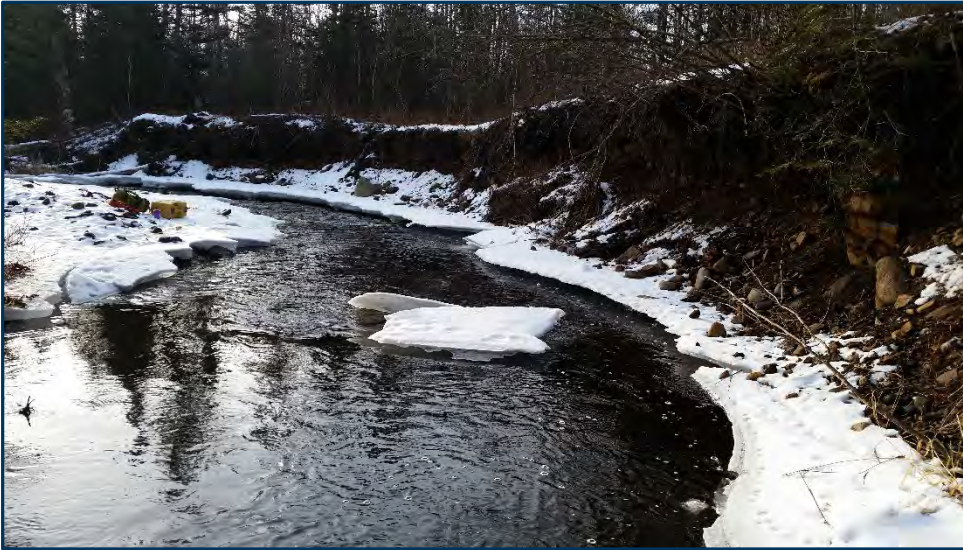
Figure 3-4 Example of stream characteristics along Reach 4

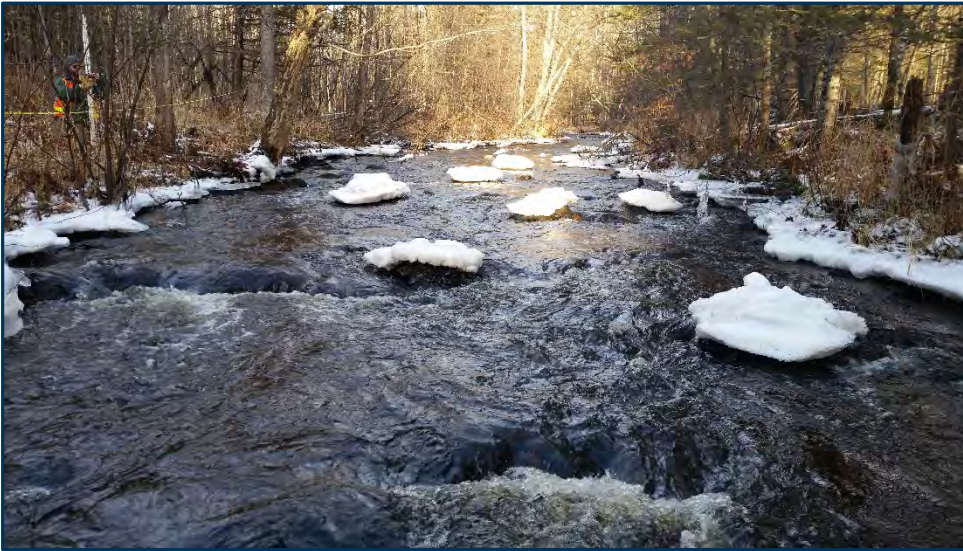
Figure 3-5 Example of stream characteristics along Reach 5

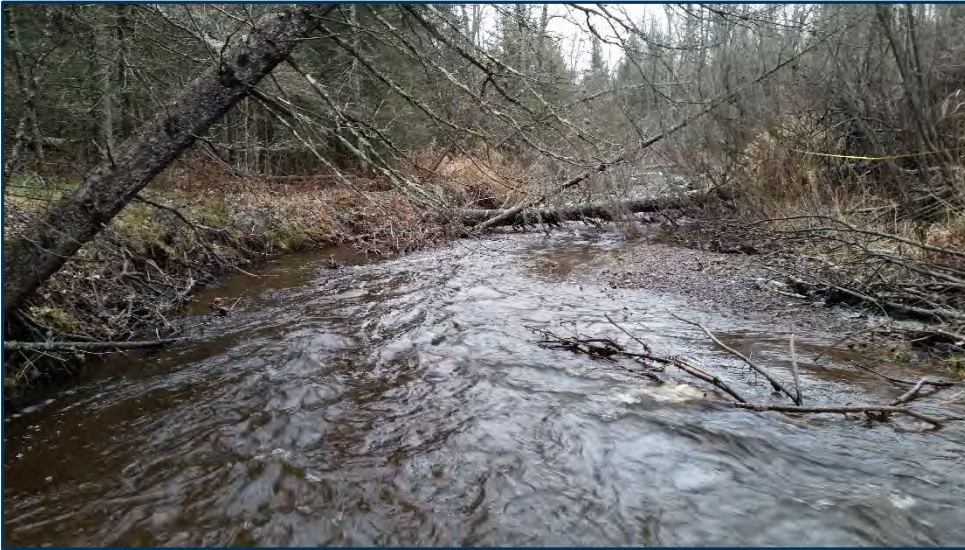
Figure 3-6 Example of stream characteristics along Reach 6

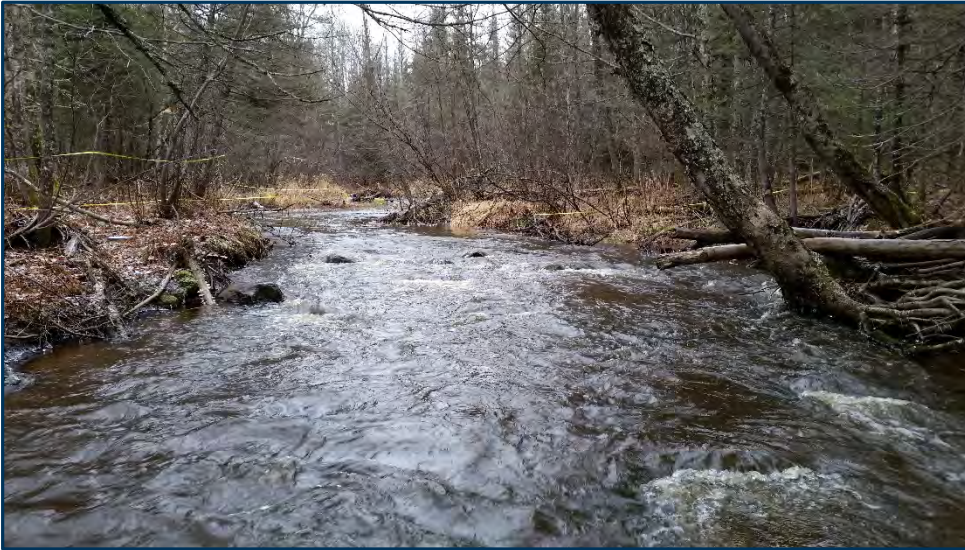
Figure 3-7 Example of stream characteristics along Reach 7

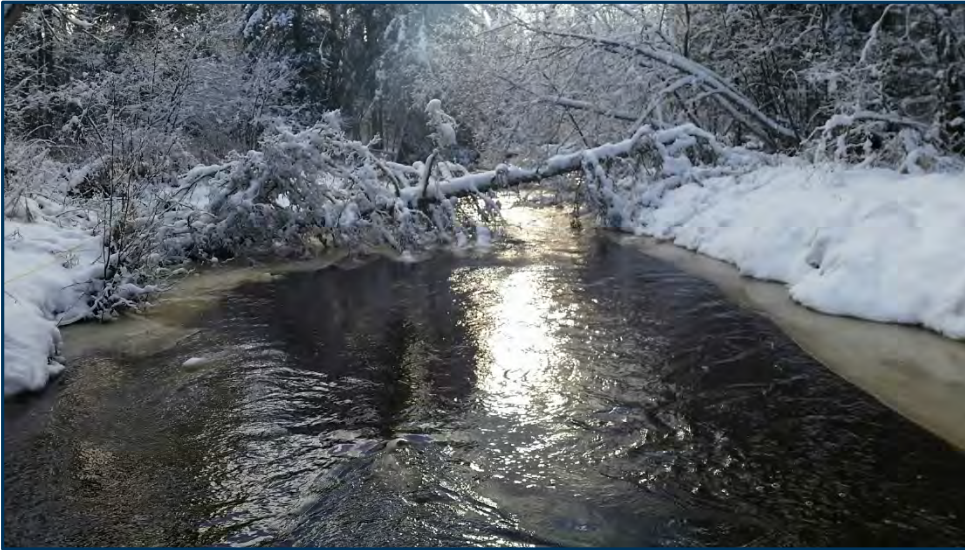
Figure 3-8 Example of stream characteristics along Reach 8

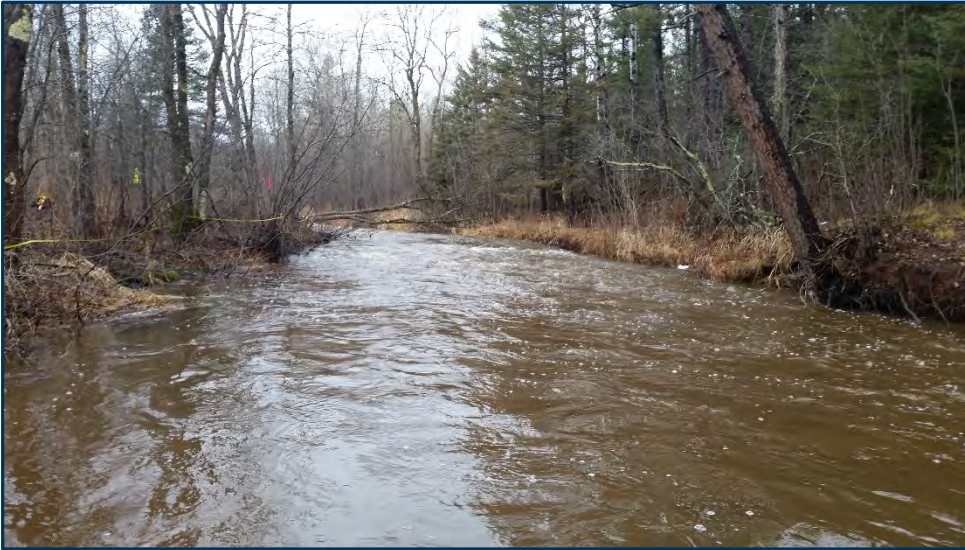
Figure 3-9 Example of stream characteristics along Reach 9

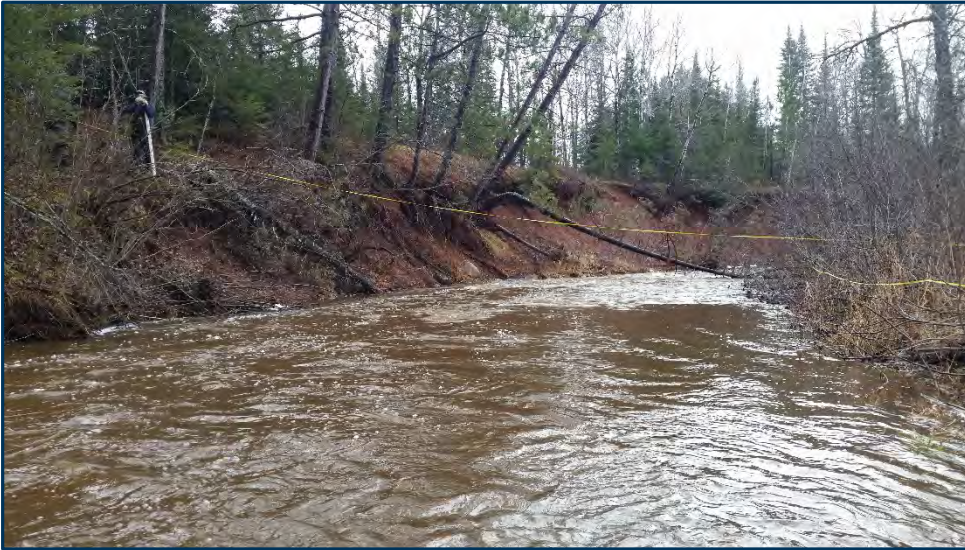
Figure 3-10 Example of stream characteristics along Reach 12
