Knife River Bank Erosion Hazard Index (BEHI)

05/2022

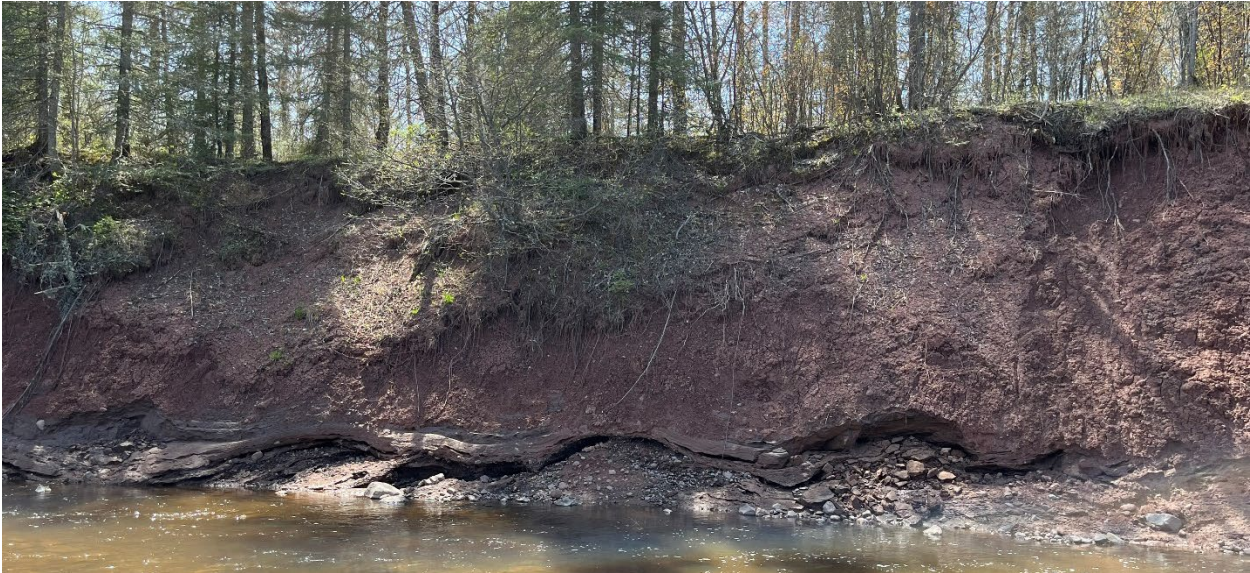
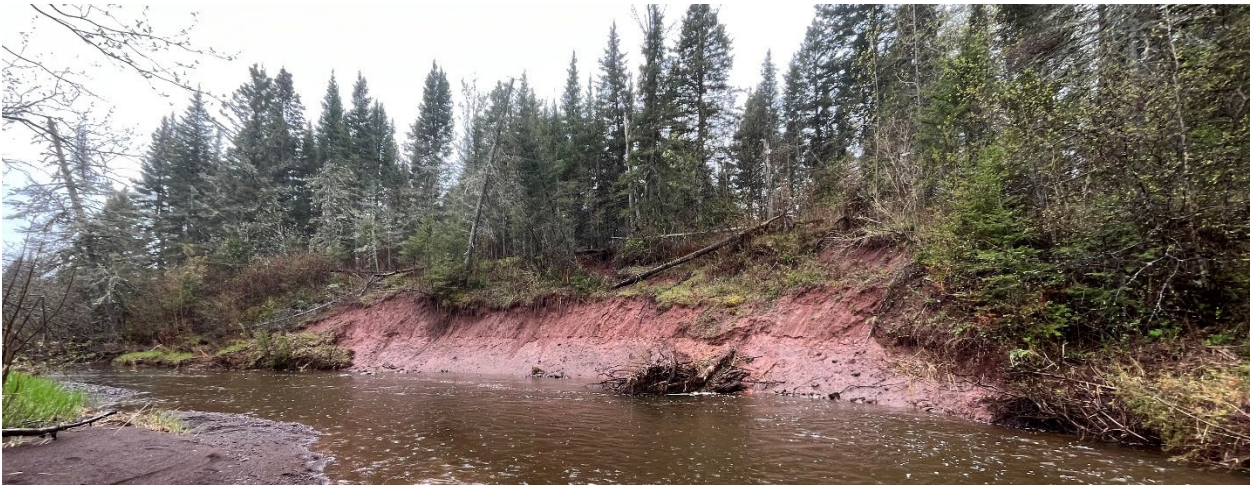
On May 25th, 2022, field scientists Emma Burgeson and Lara Scott collected field measurements to conduct a Bank Erosion Hazard Index (BEHI) analysis (Appendix 1) on three degrading banks. These banks occur between County Road 11 and County Road 9 on the main stem of the Knife River near Two Harbors, MN. Each of the three banks have similar geomorphic characteristics. The average height is 25 ft, with a range from 20-40ft at the highest point. The vegetation above these banks consists of shrubs, aspen, and dying balsam fir that no longer provide support to the bank with their root mass. Each of the banks is laden with trees that are either partially or entirely slumped into the river.
